# Bellingen Water Quality Management Plan

Final Report  
June 2022

**BELLINGEN  
SHIRE COUNCIL**

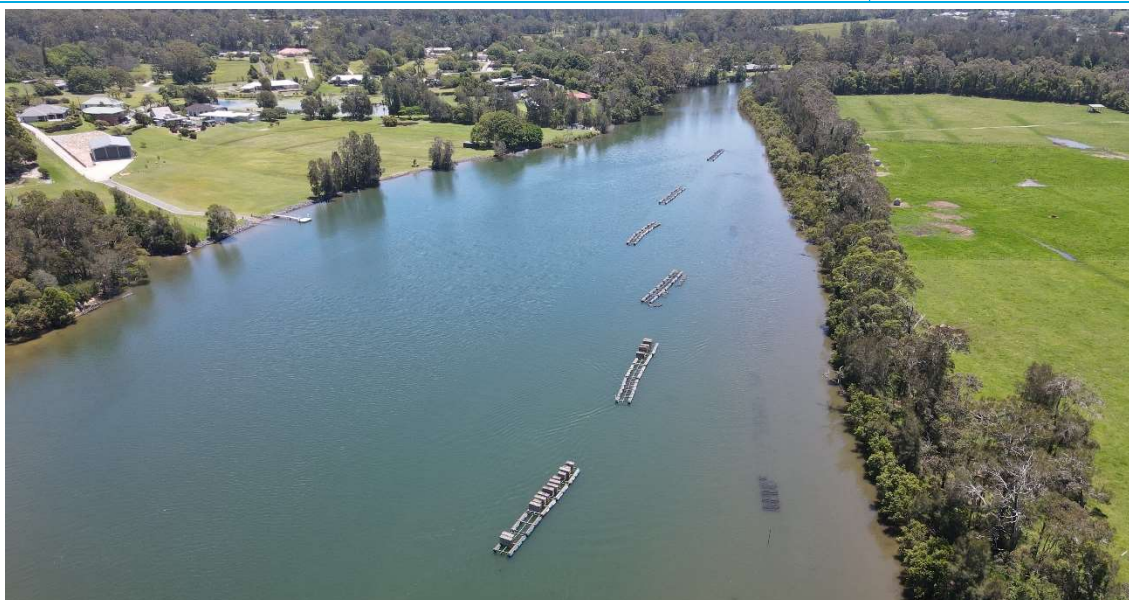
Figure 4-6. Oyster beds in the lower estuary - critical receptors for poor water quality

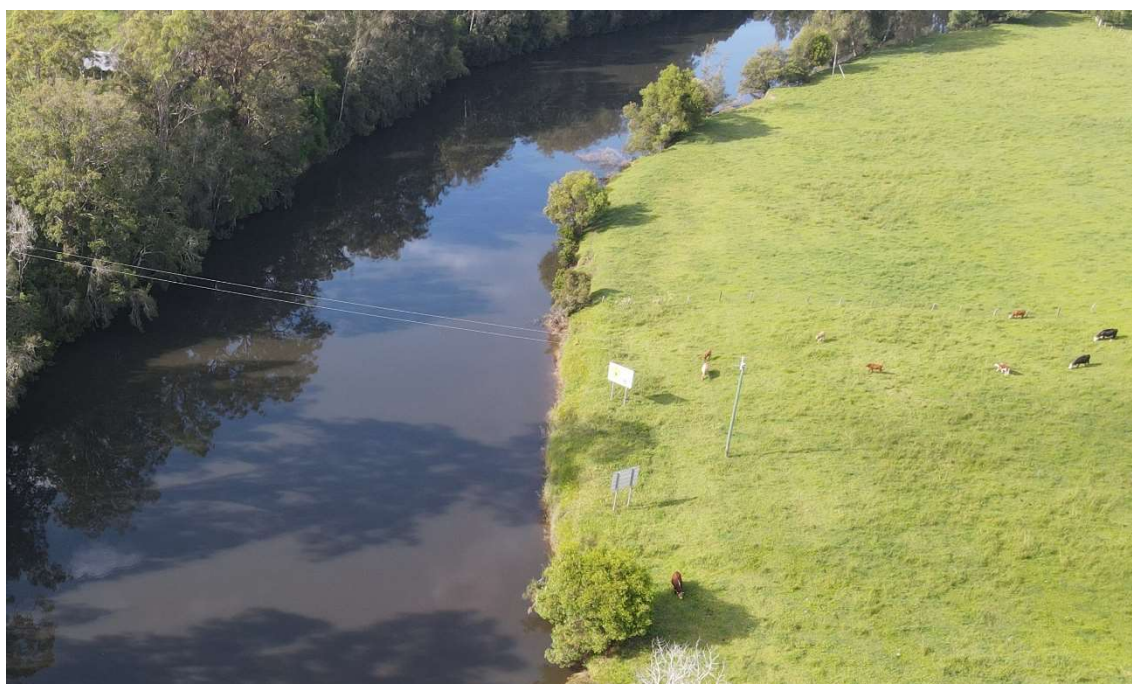
Figure 4-8. Cleared water way banks in the Kalang catchment

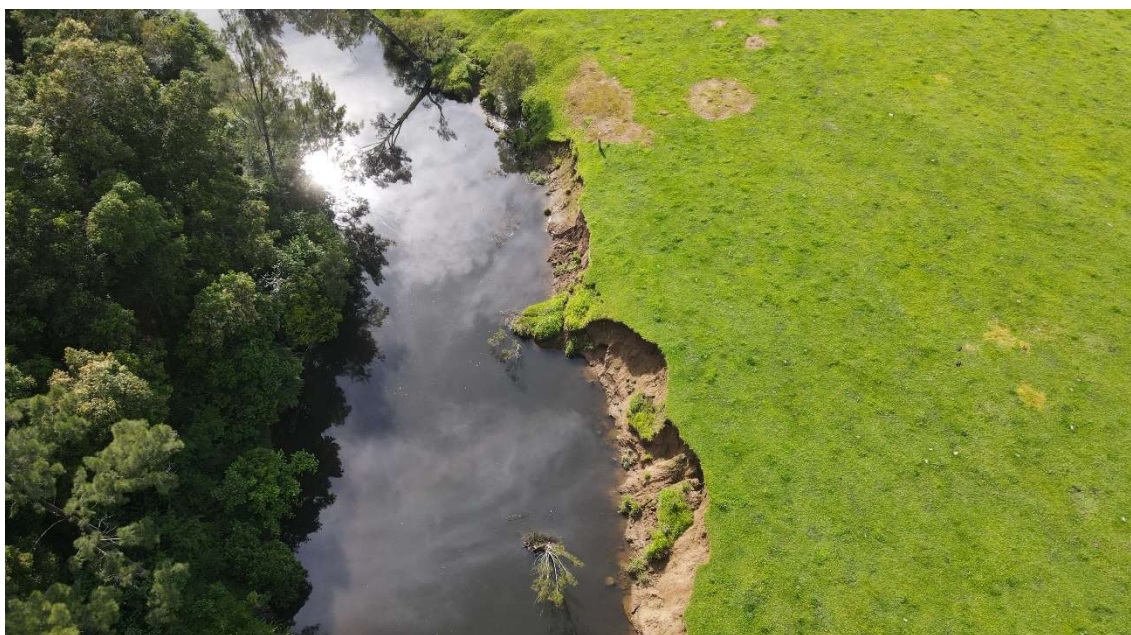
Figure 4-9. Bank Erosion within the Kalang River (JBP, 2021)

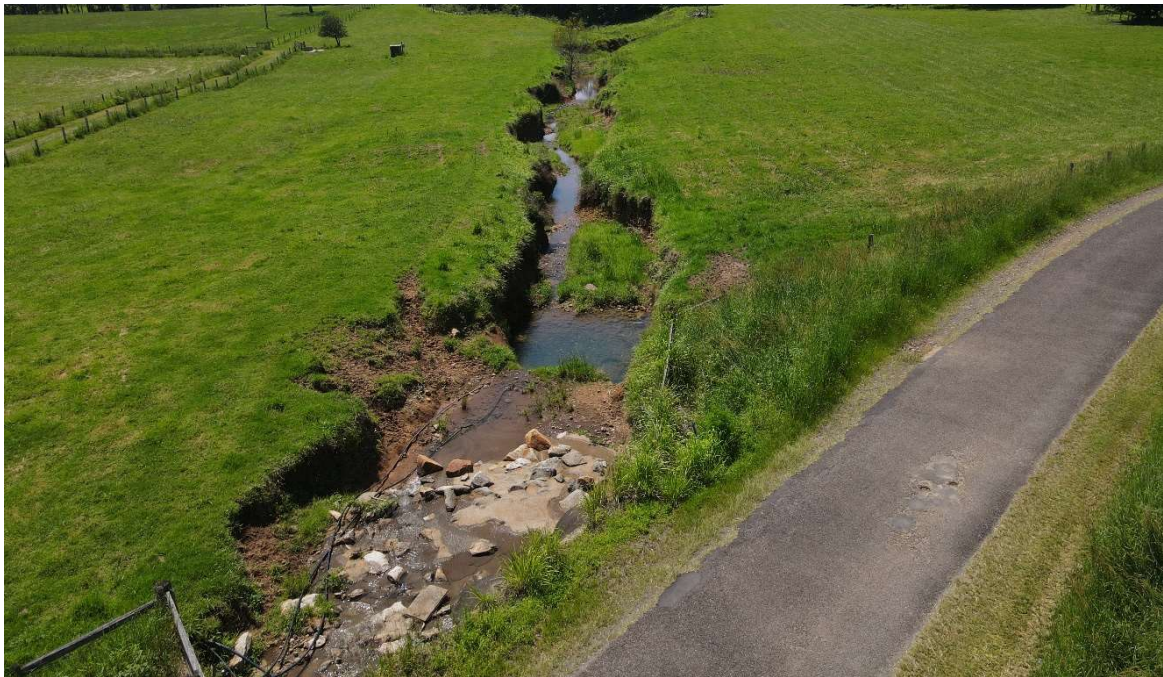
Figure 4-10. Bank erosion adjacent to Gordonville Road (JBP, 2021).

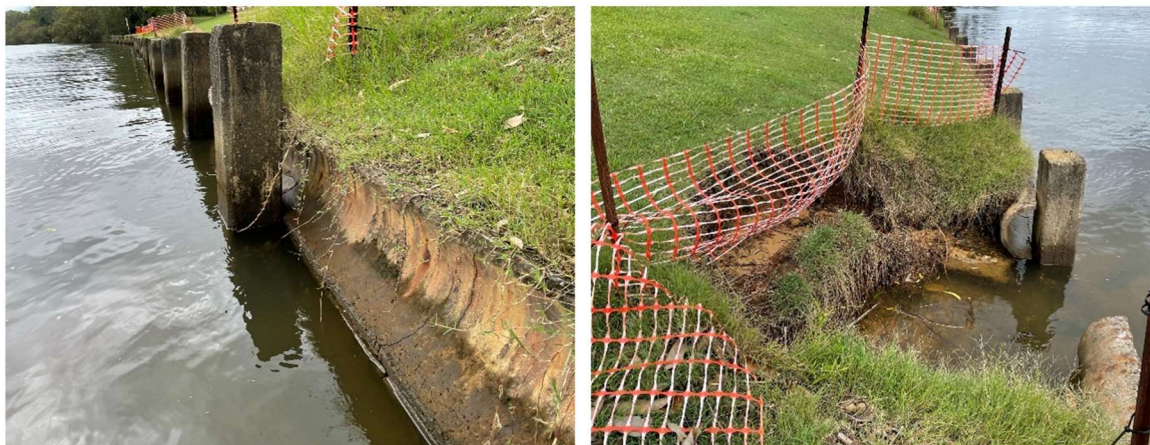
Figure 4-12. Top: Mylestom bank failures (JBP 2021).

Based on site inspections, the bank restoration would include toe armour, reprofiling, and the development of several vegetation zones along the bank. The nearshore zone could also consider reef balls or habitat-creation piles/logjams.

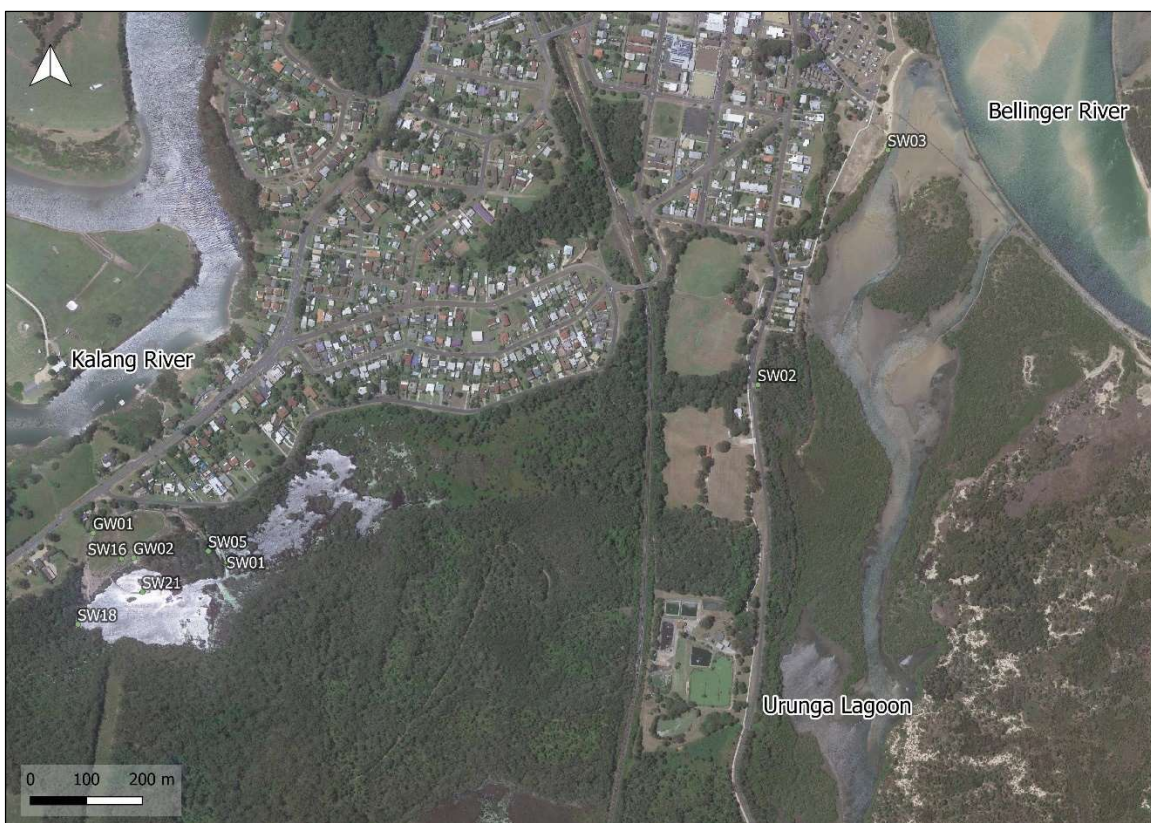
Figure 4-14. Monitoring sites for contaminated land remediation project at Urunga APP.

- Groundwater measurements all comply with guidelines for drinking water with the exception of pH and nickel. The good water quality results from downgradient of the monocell imply that the monocell is maintaining its integrity and that the treatment and storage of polluted materials has been successful.
- Groundwater dynamics have not been affected by remediation efforts.
- Overall remediation efforts have had a positive impact on water quality.
